Goldsborough Estuary/Shelton Harbor Restoration

Project website: <https://sheltonharbor.org/>

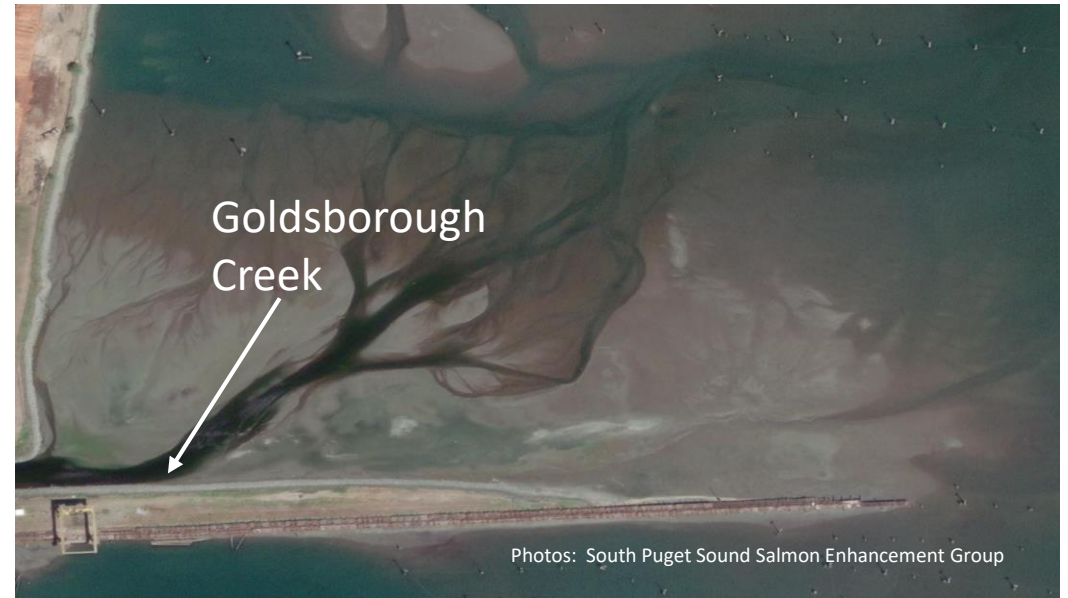
Figure 1. Goldsborough Creek estuary before restoration.

In the early 1900s, the Goldsborough Creek estuary was dredged to create what is now Shelton Harbor. In 2016, a unique restoration partnership was formed to restore the North Harbor. The group consisted of multiple public and private landowners, the Squaxin Island Tribe, and the South Puget Sound Salmon Enhancement Group.

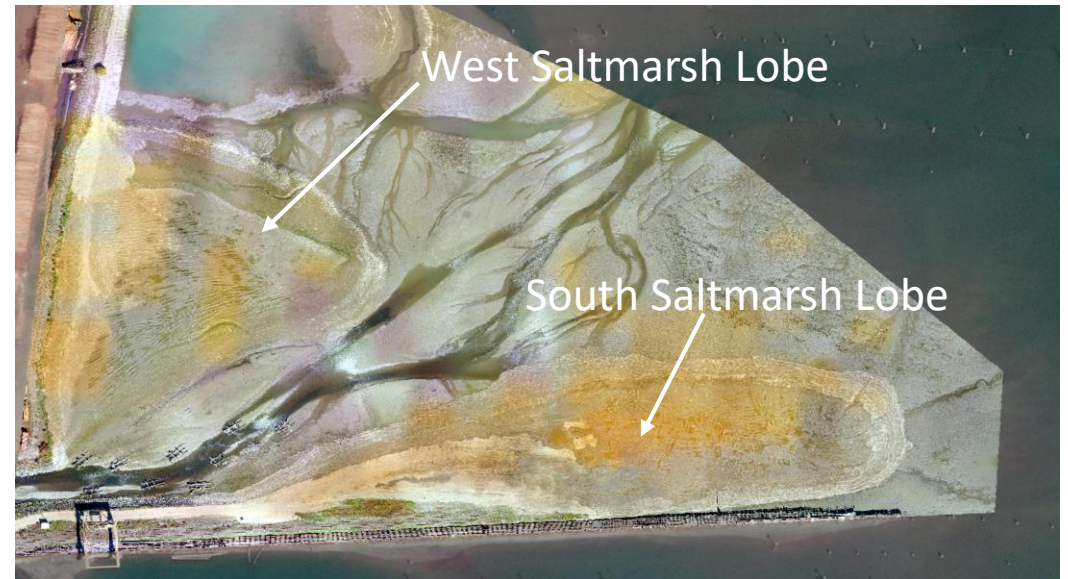
Figure 2. Goldsborough Creek estuary after Phase 1 and Phase 2 restoration.

In the first phase, engineered large wood structures (LWD) were installed at the mouth of the creek to capture sediment and act as a grade control structure. The entire North Harbor work site was placed into conservancy and adjacent high-quality riparian uplands and wetlands were purchased. The second phase consisted of importing clean sediment from local sources to construct the West (2019) and South (2020) saltmarsh lobes. Design considerations included providing elevations that would support target saltmarsh species and accommodating sea-level rise.

- 52 acres of tidelands and 14 acres of upland placed into conservation.
- 155 creosote pilings removed.
- 9 engineered logjams installed.
- ≈ ½ mile of rip rap bulkhead removed.
- ¼ mile x 50' riparian zone established. 10,000 shrubs and trees planted.
